Channel Change on the Santa Cruz River, Pima County, Arizona, 1936–86

By JOHN T.C. PARKER

U.S. GEOLOGICAL SURVEY
Open-File Report 93—41

Prepared in cooperation with the
PIMA COUNTY DEPARTMENT OF TRANSPORTATION
AND FLOOD CONTROL DISTRICT

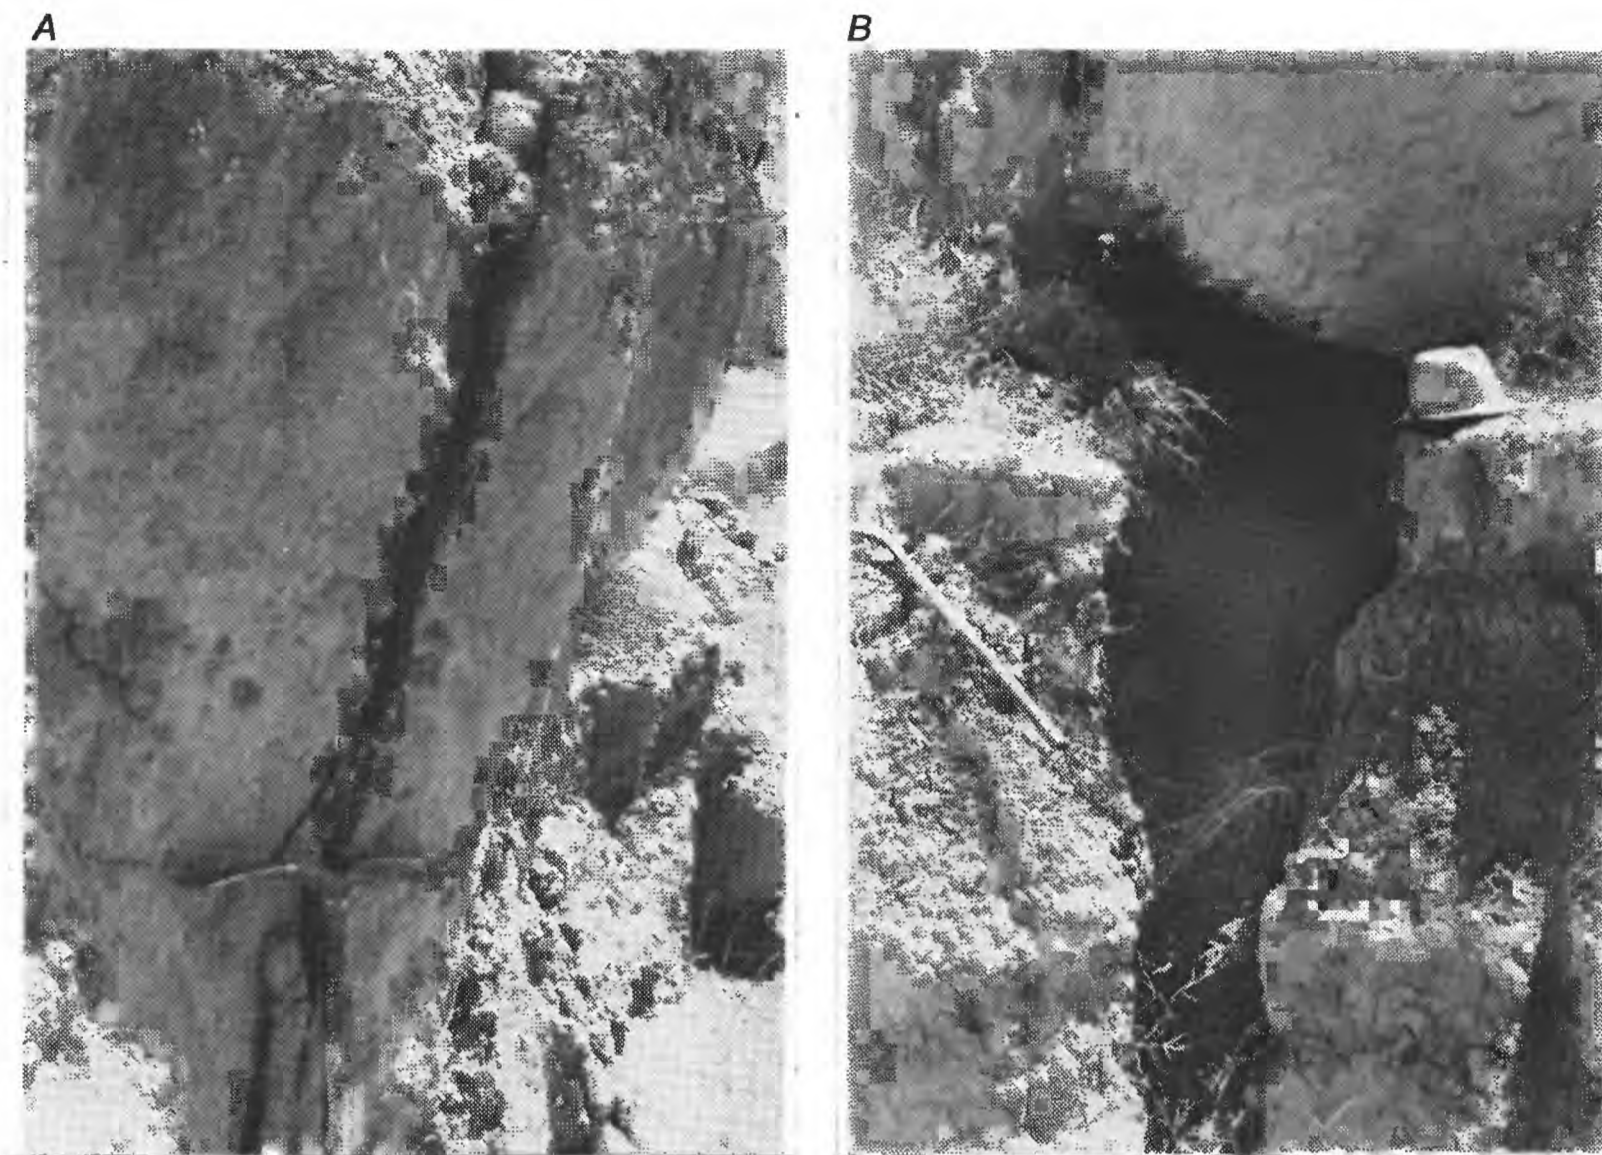
Figure 12. Structural weakening of arroyo walls, Santa Cruz River. *A*, Tension cracking leads to block failure of cohesive alluvium. *B*, Pipes enlarge and may produce cavernous discontinuities in alluvium.

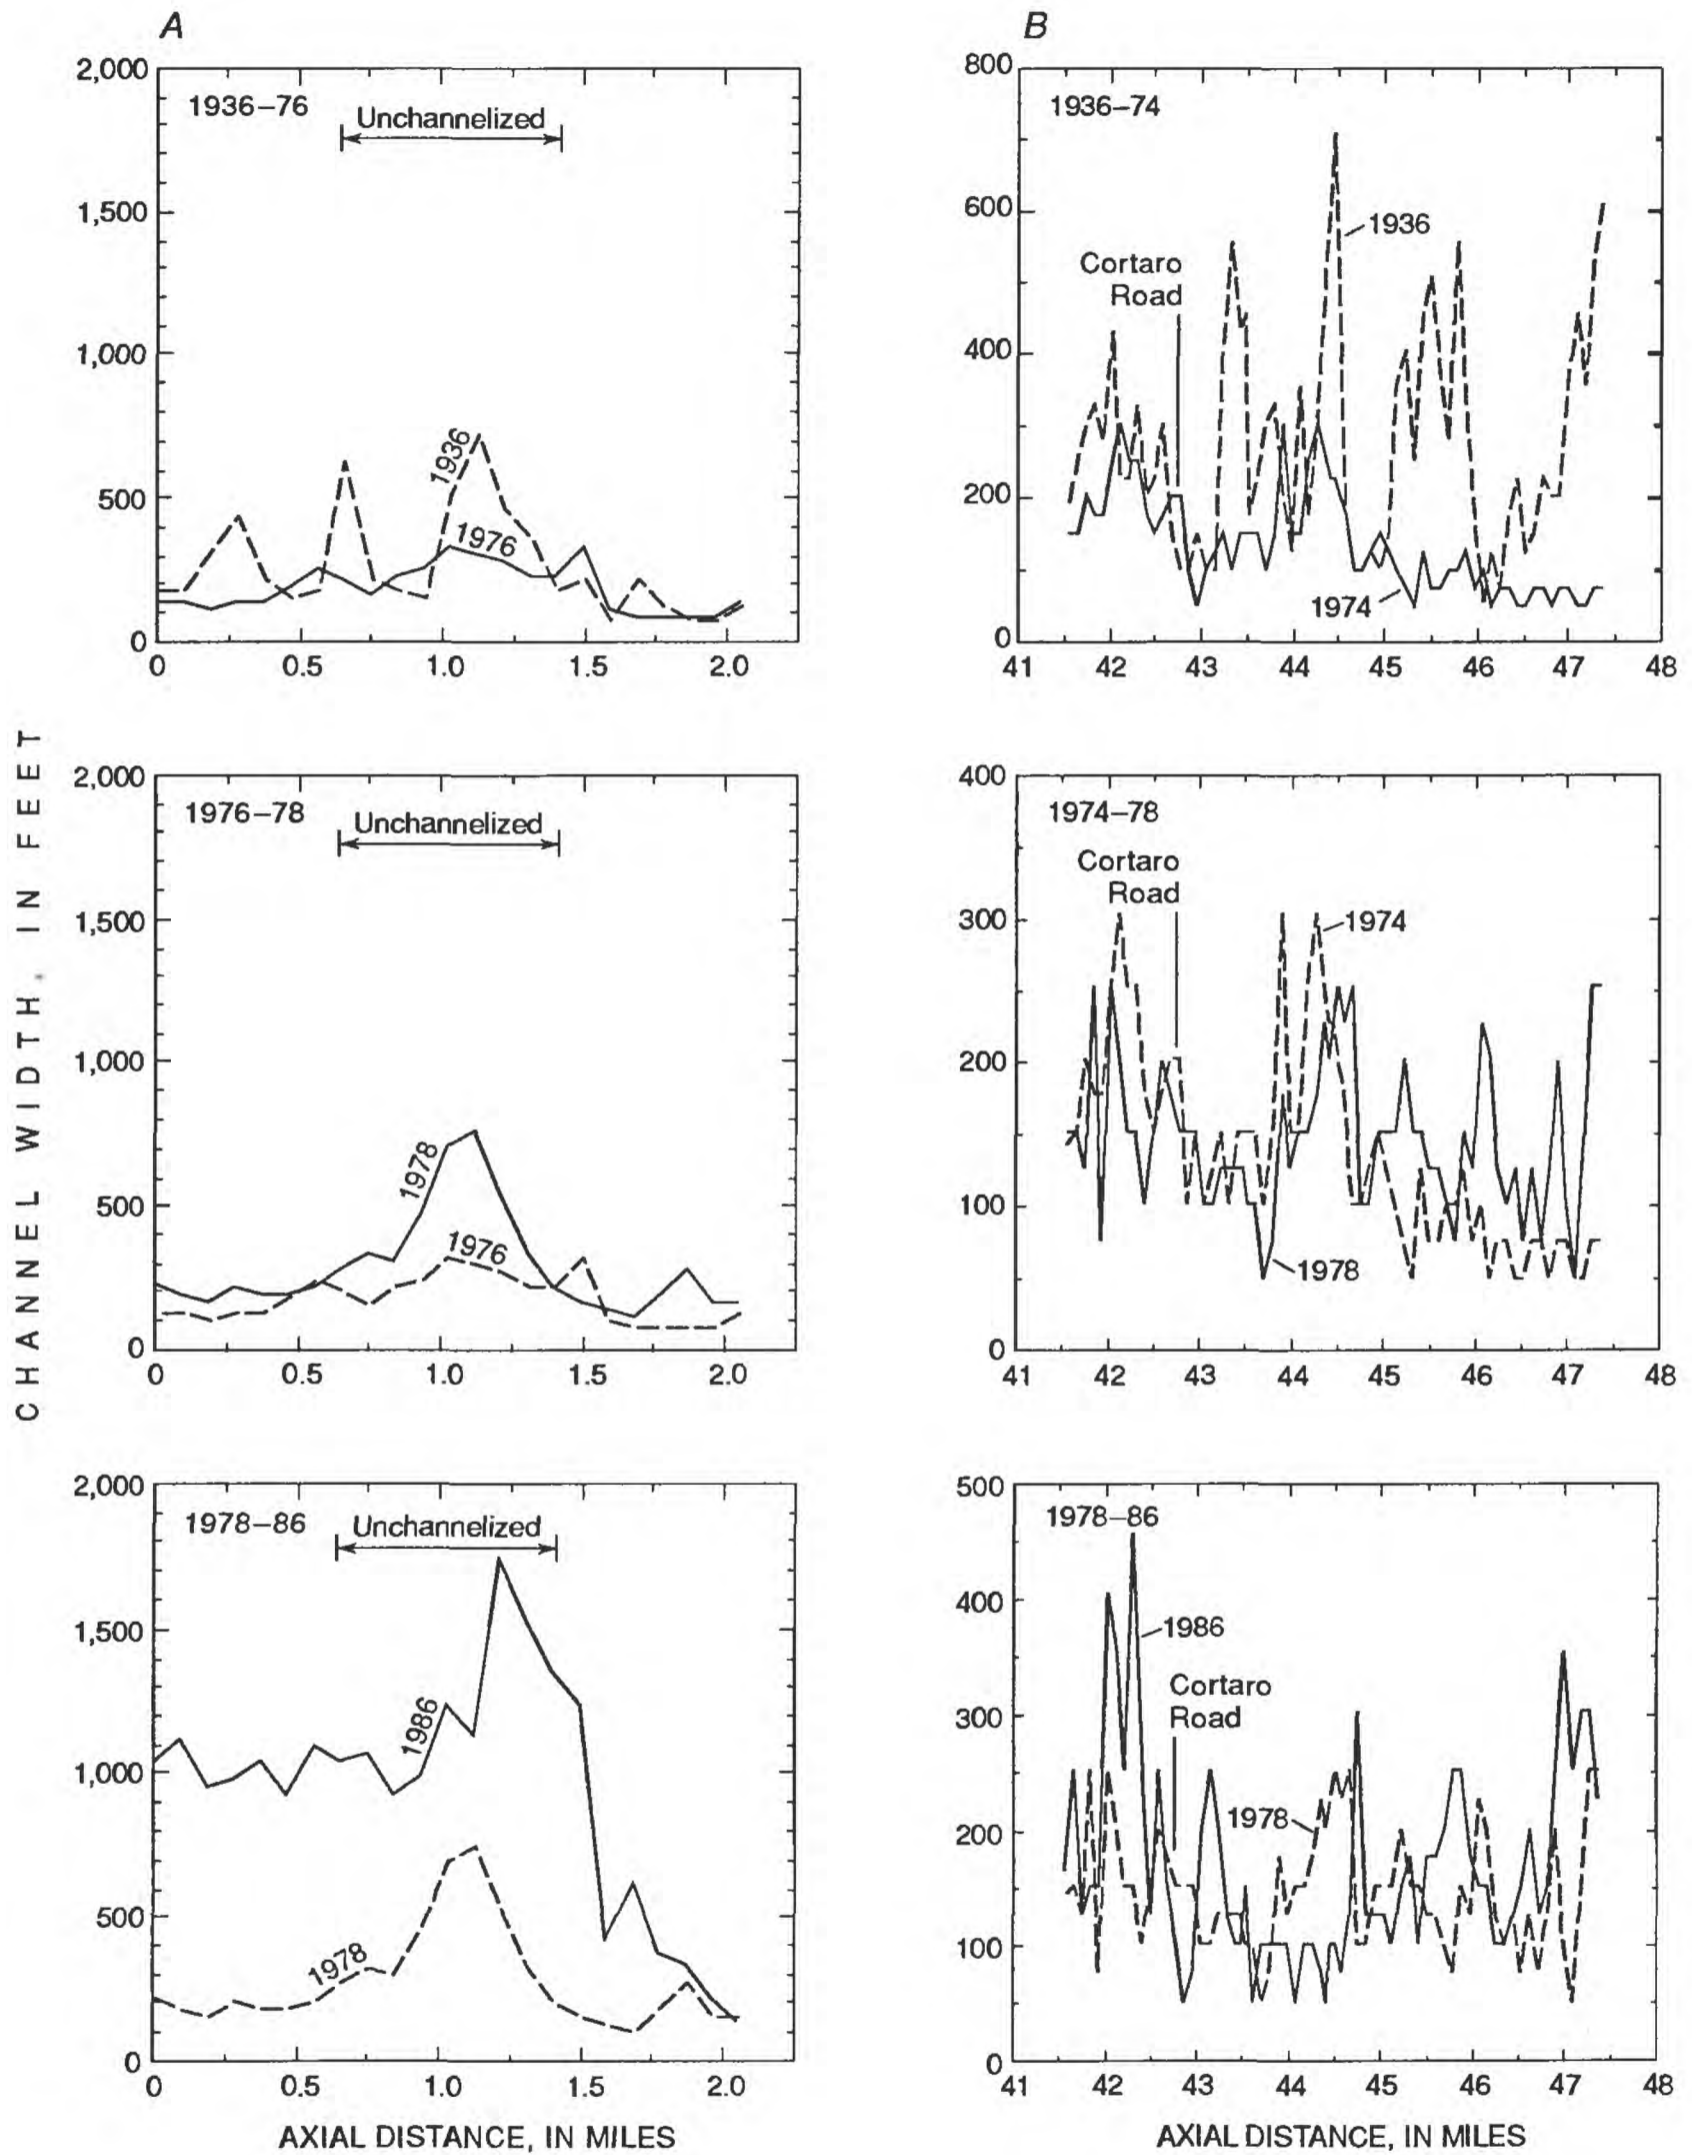
Figure 13. Channel-width changes on the Santa Cruz River. *A*, Upper Canoa reach. *B*, Lower Cortaro reach.

Between 1976 and 1986, about 1,200 ft of widening occurred on the upper Canoa reach, which is characterized by low banks composed of weakly cohesive sand and gravel (fig. 13A). The channel was stable from the 1950's, when much of the reach was channelized and banks were armored, until the flood of 1977 during which widening generally was confined to unchannelized sections. The 1983 flood produced a fivefold to sixfold increase in channel width along channelized and unchannelized sections. Widening upstream from

axial distance 0.7 mi (fig. 13A) was the result of lateral corrosion by high flow; widening in the unchannelized part of the reach between 0.7 and 1.6 mi was caused by channel widening on the outside of a meander as it migrated downstream. Migration of the meander on the Canoa reach was accompanied by almost complete point-bar removal, and only a coarse lag was left in its place.

narrowed after 1966 as a result of vegetation growth in response to perennial flow (fig. 13B; Hays, 1984), and in most of the reach the 1977 flood caused little widening. The 1983 flood stripped vegetation and eroded the generally sandy, gravelly banks. Hays (1984) reported an increase in mean width from 250 to about 450 ft on the Marana reach between Avra Valley Road and Trico-Marana Road after the 1983 flood. Aerial photographs taken in 1984 indicate that mean width on the Cortaro reach between Cortaro Road and Avra Valley Road increased from 150 to 270 ft as a result of the 1983 flood. By 1986, however, mean width of the Cortaro reach had declined to 170 ft as a result of subsequent low-flow incision, in-channel deposition, and revegetation.

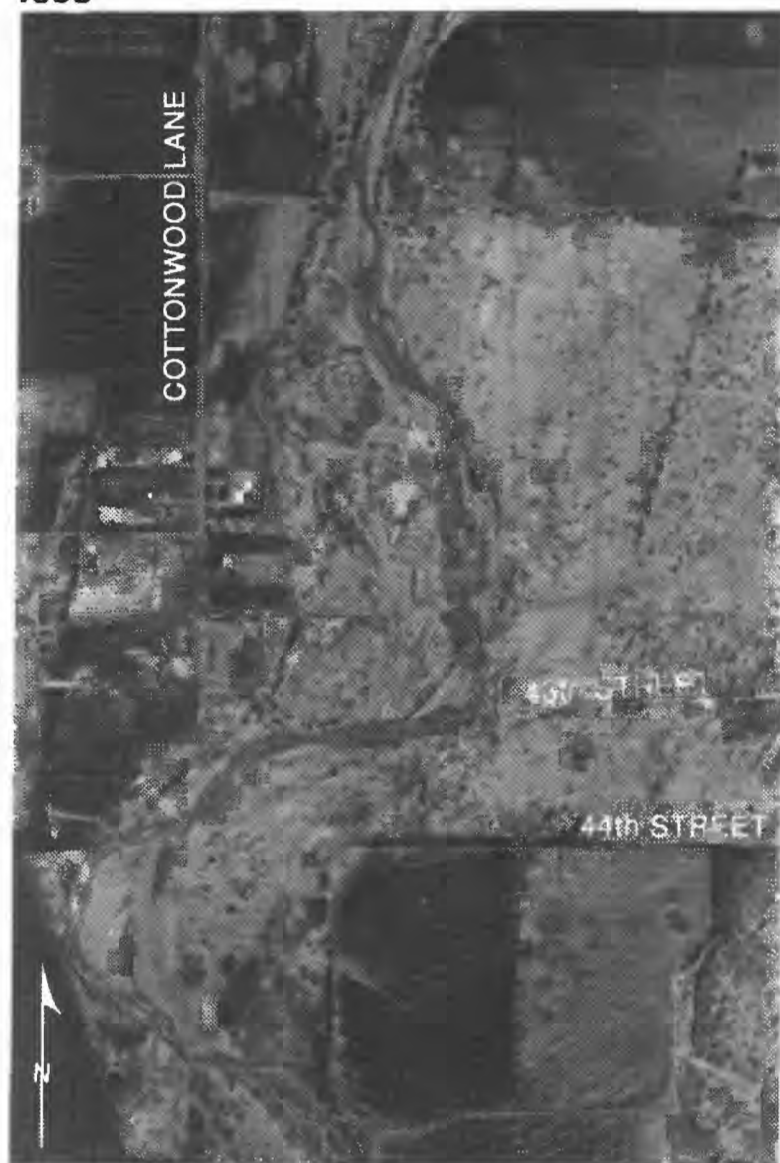
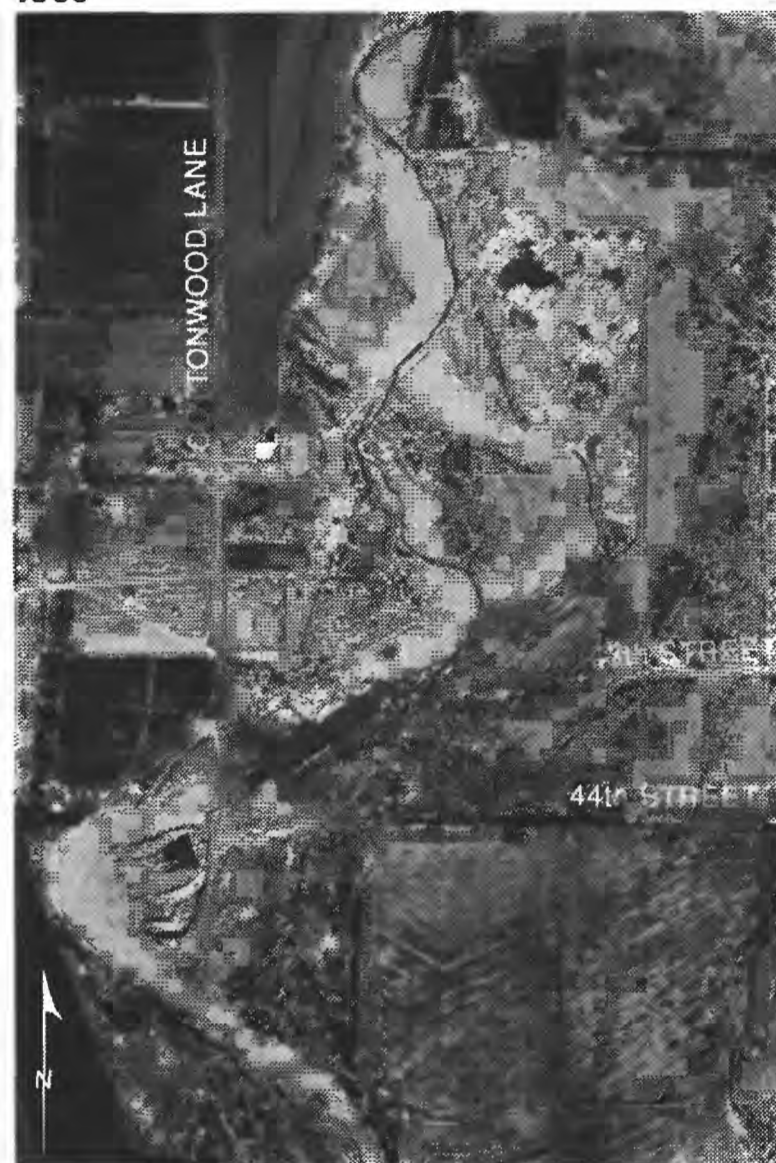
Figure 14. Avulsion within the arroyo in the lower San Xavier reach north of 44th Street, 1953–60. About 4 feet of aggradation occurred in the reach during that interval. (Source: Cooper Aerial Survey, 1953 and 1960.)

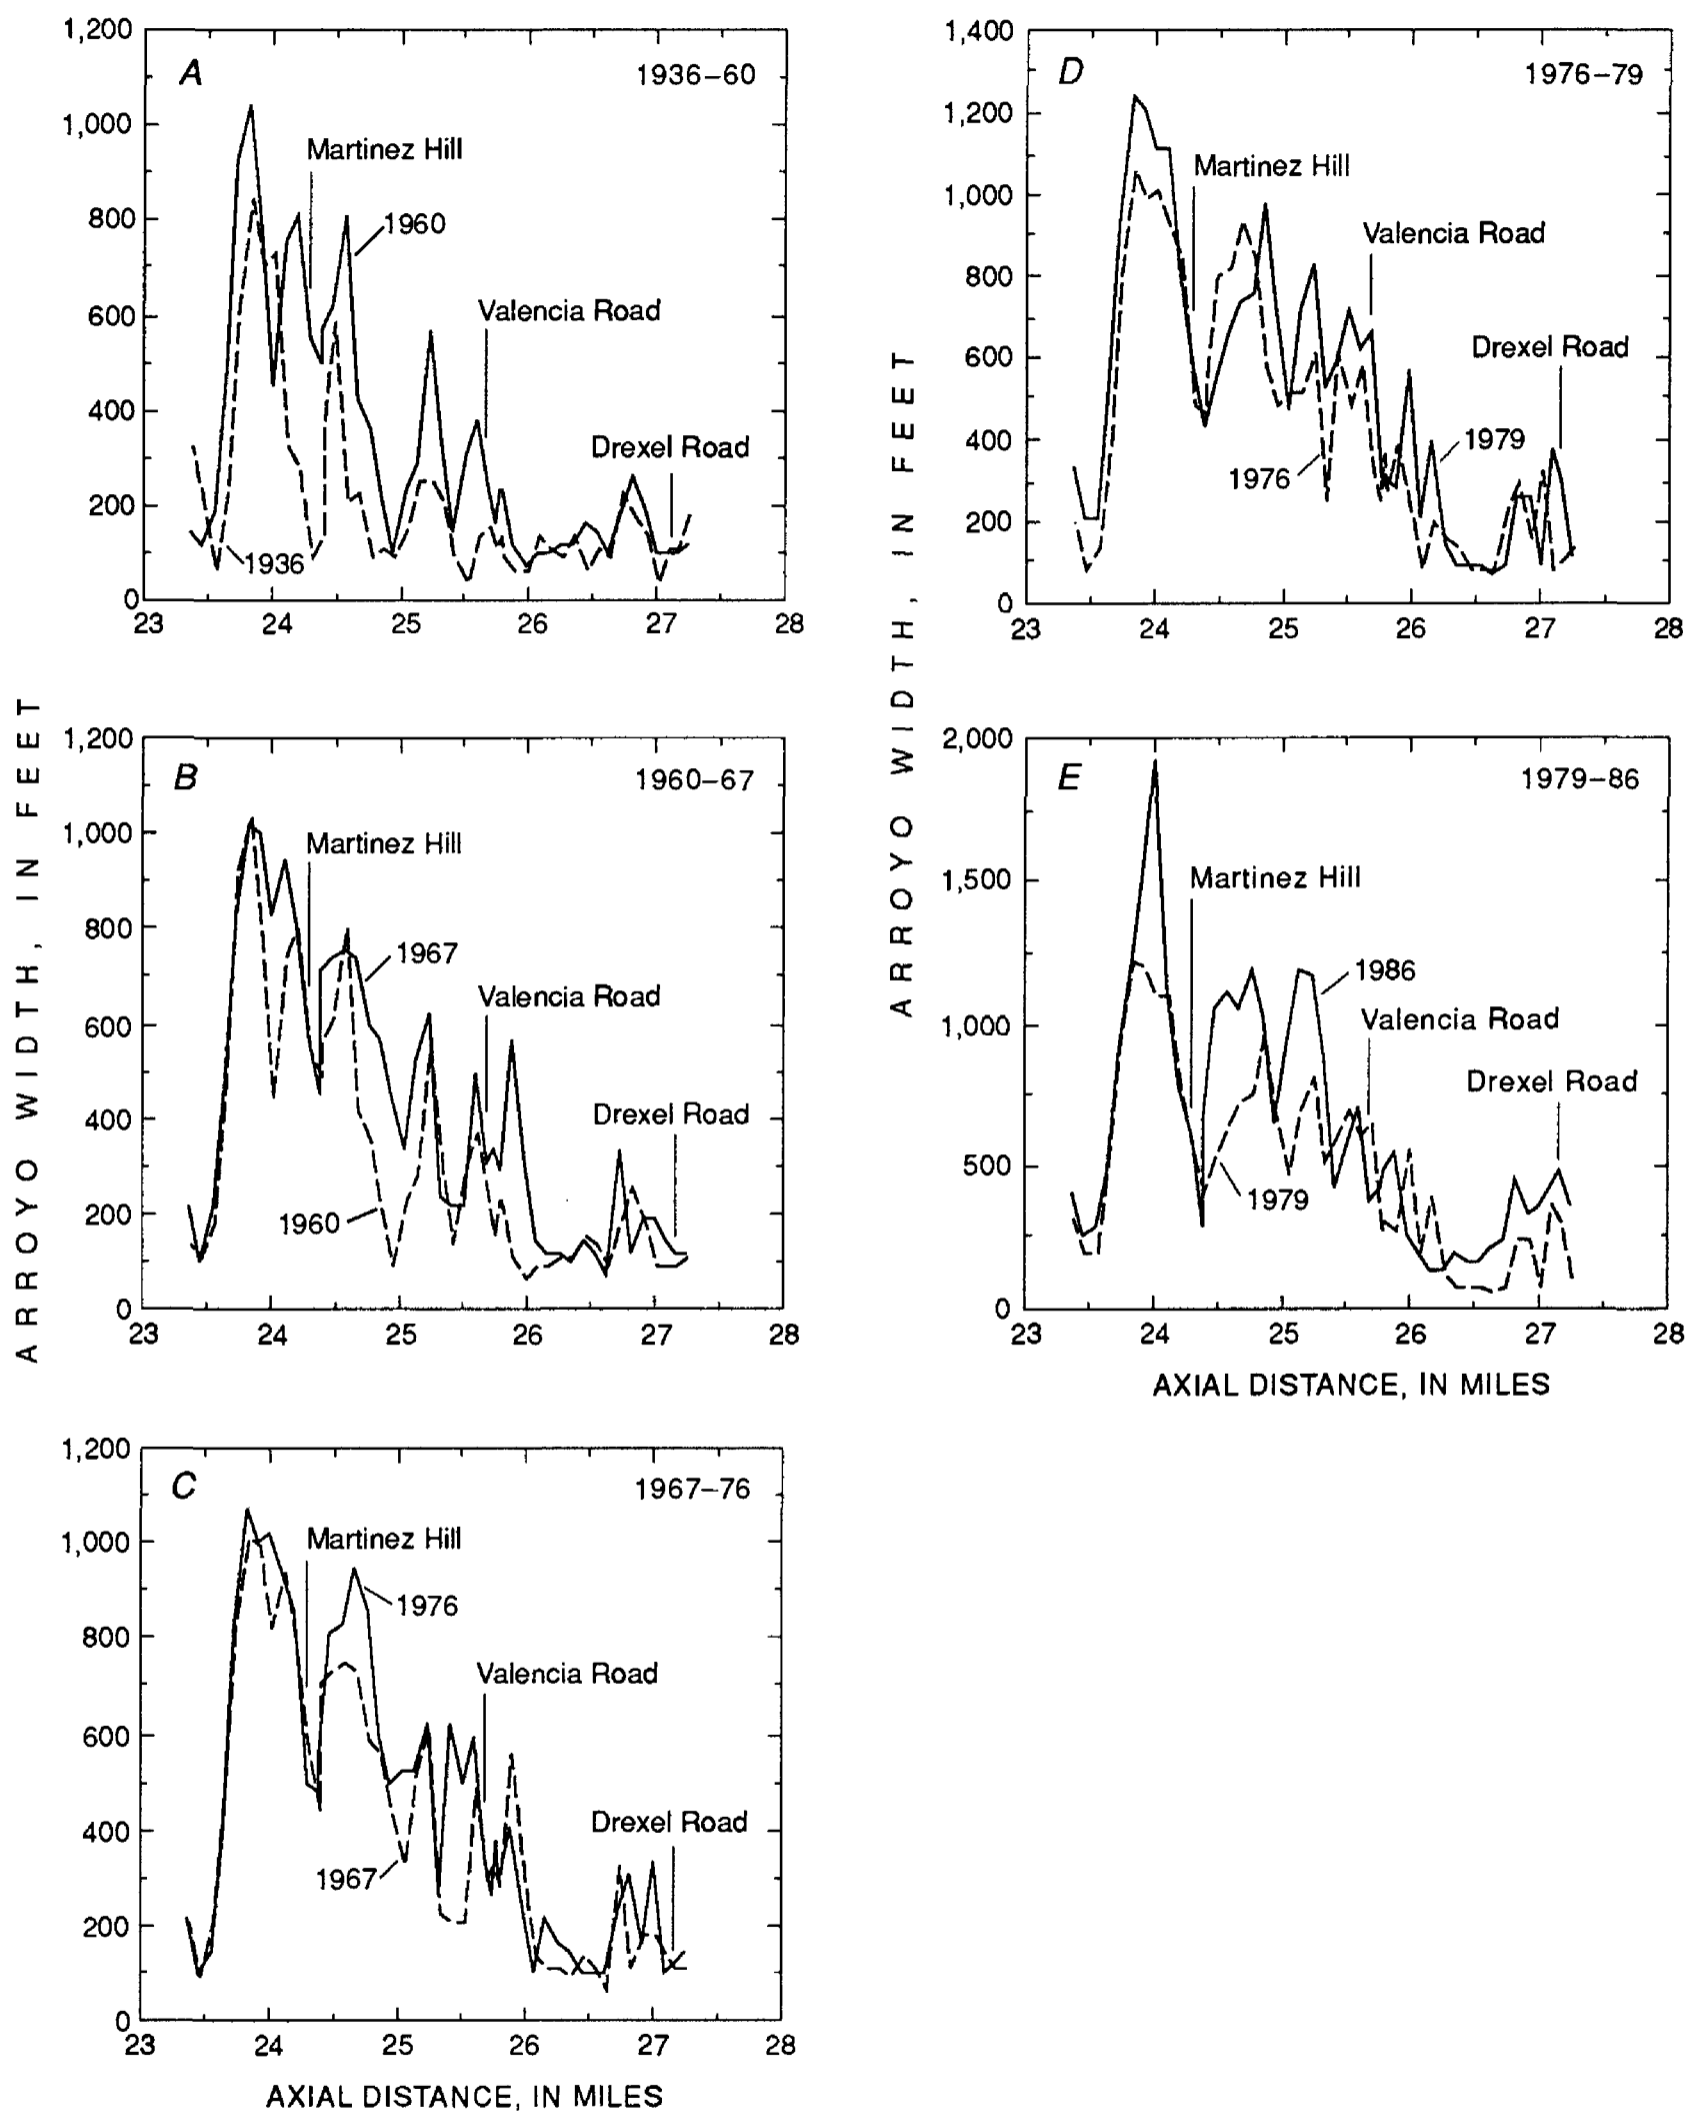
Figure 15. Arroyo widths on the lower San Xavier reach near Martinez Hill, 1936-86.

The San Xavier reach, especially the lower reach above Martinez Hill to Valencia Road, has undergone the most extensive and continuous arroyo widening on the Santa Cruz River (fig. 15). The channel was incised as much as 30 ft in silt and sand of Holocene age, and about 1,200 ft of widening occurred at

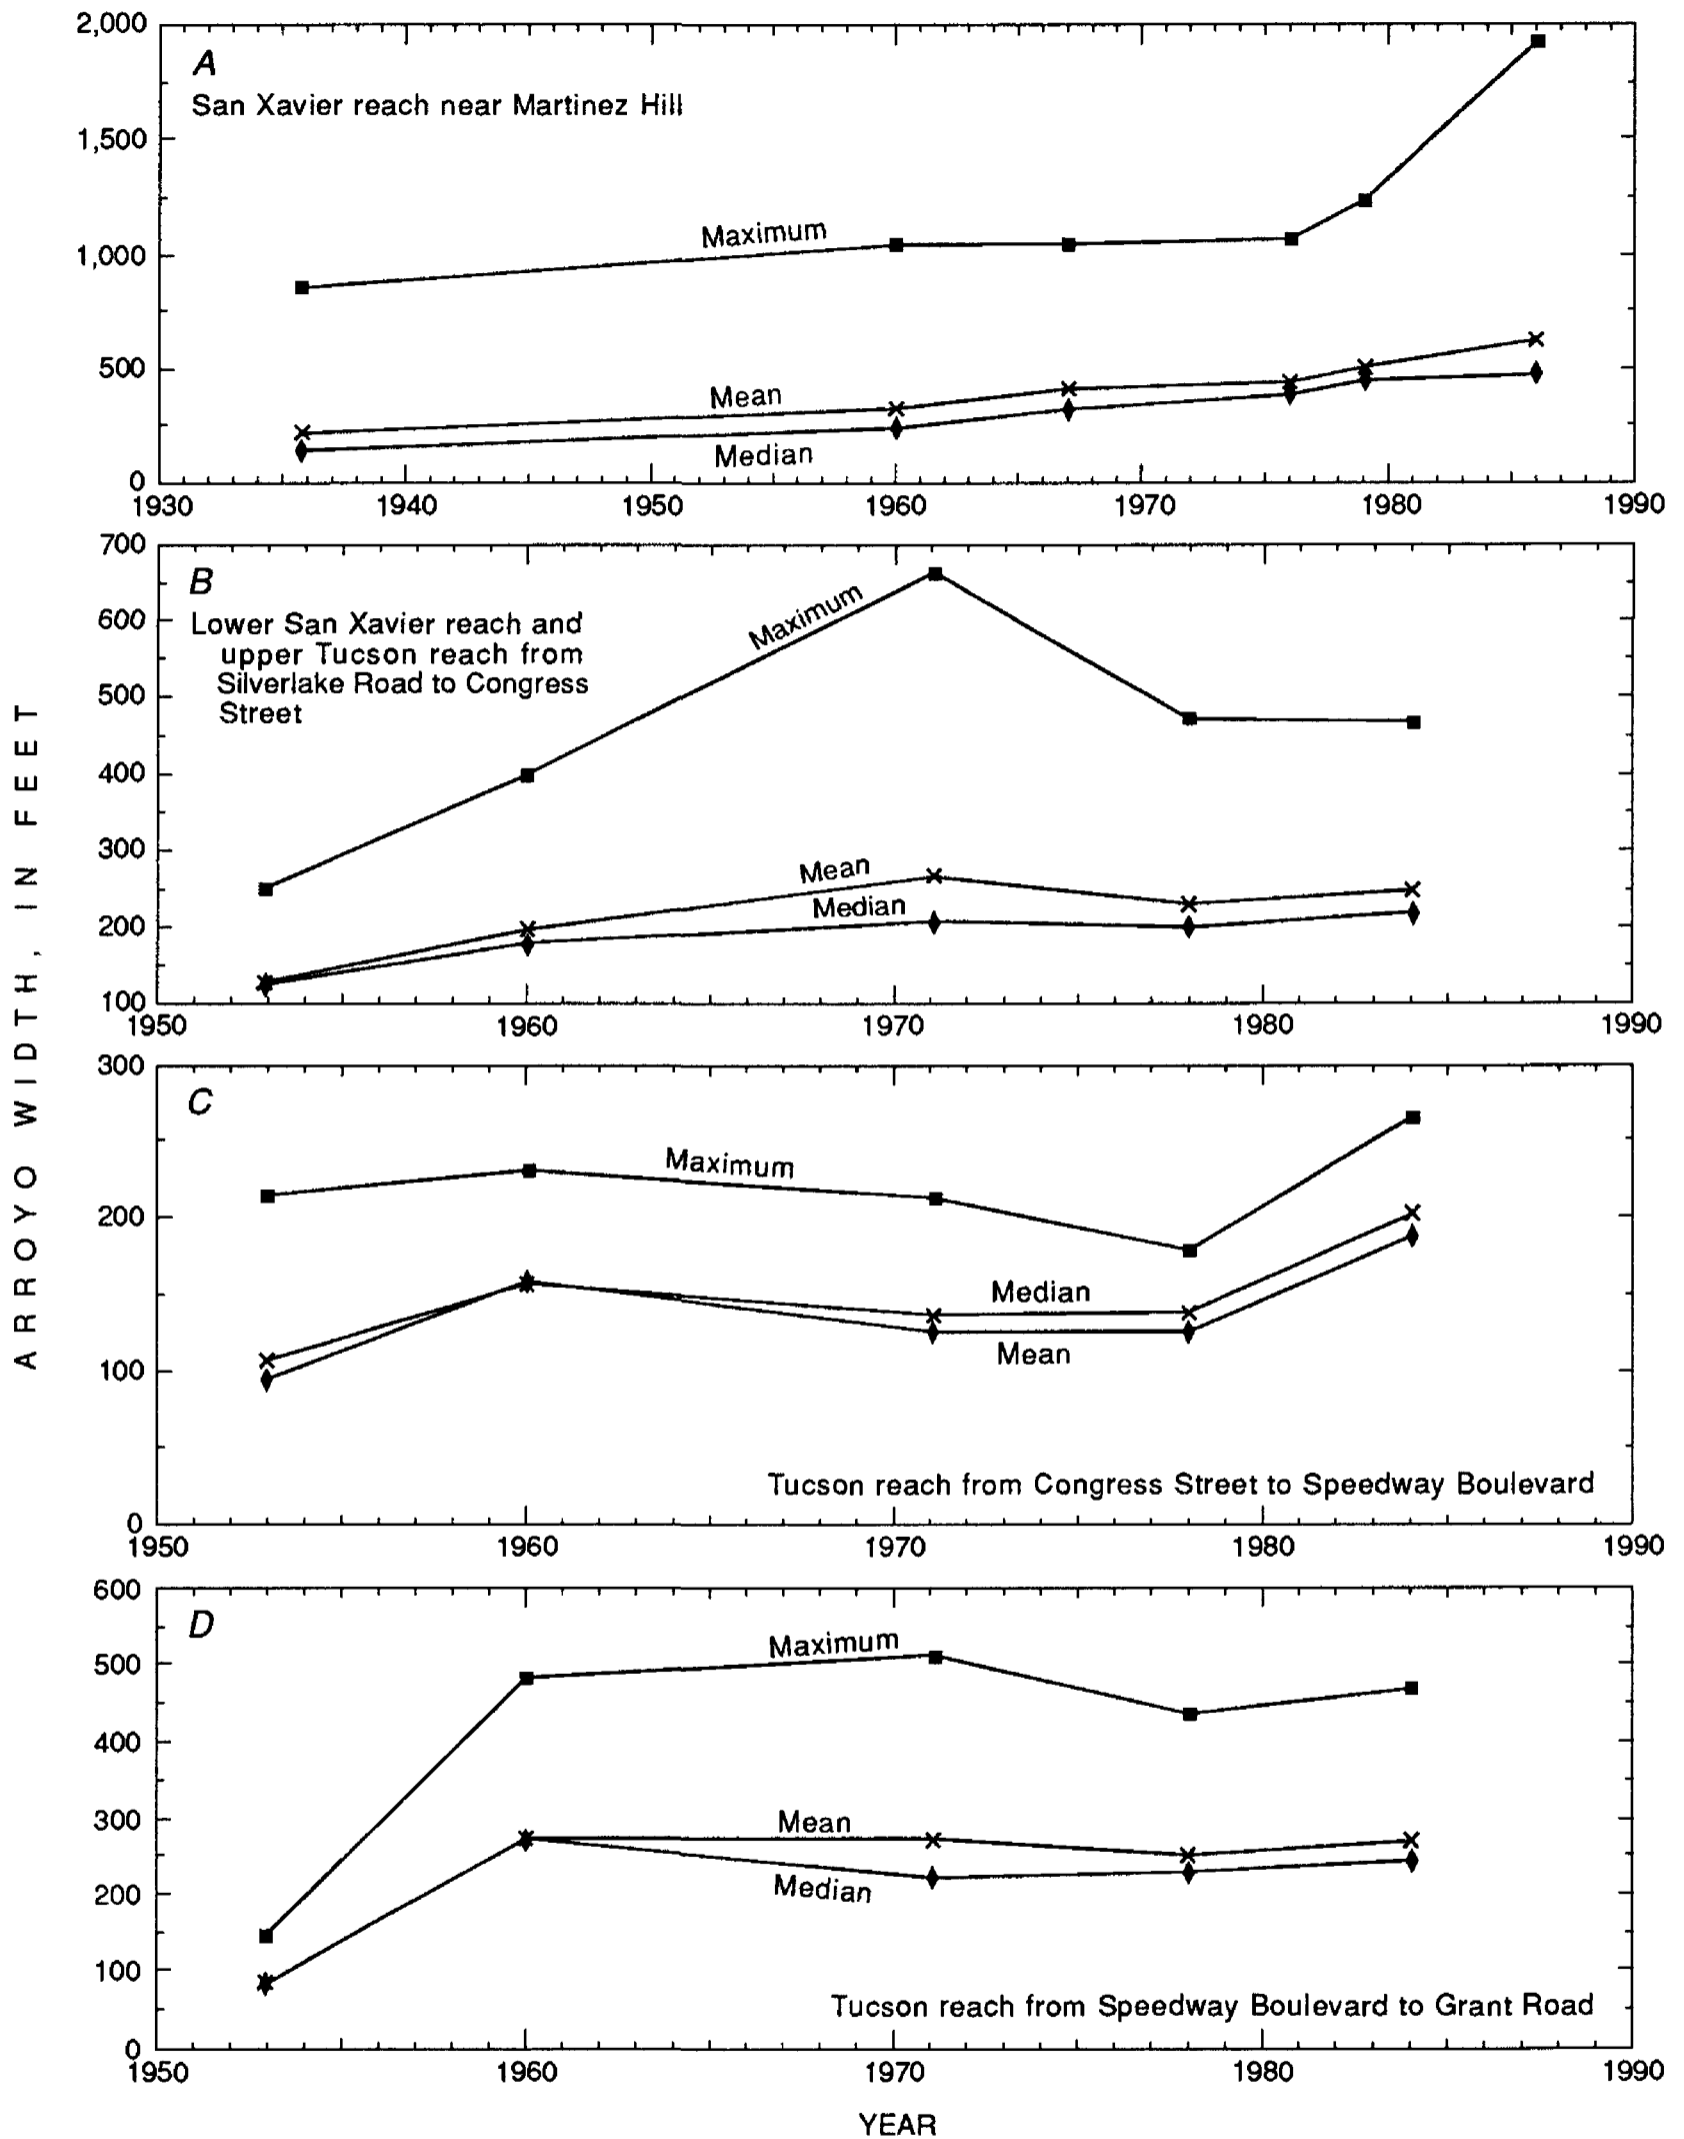
Figure 16. Arroyo-widening statistics for the San Xavier and Tucson reaches.

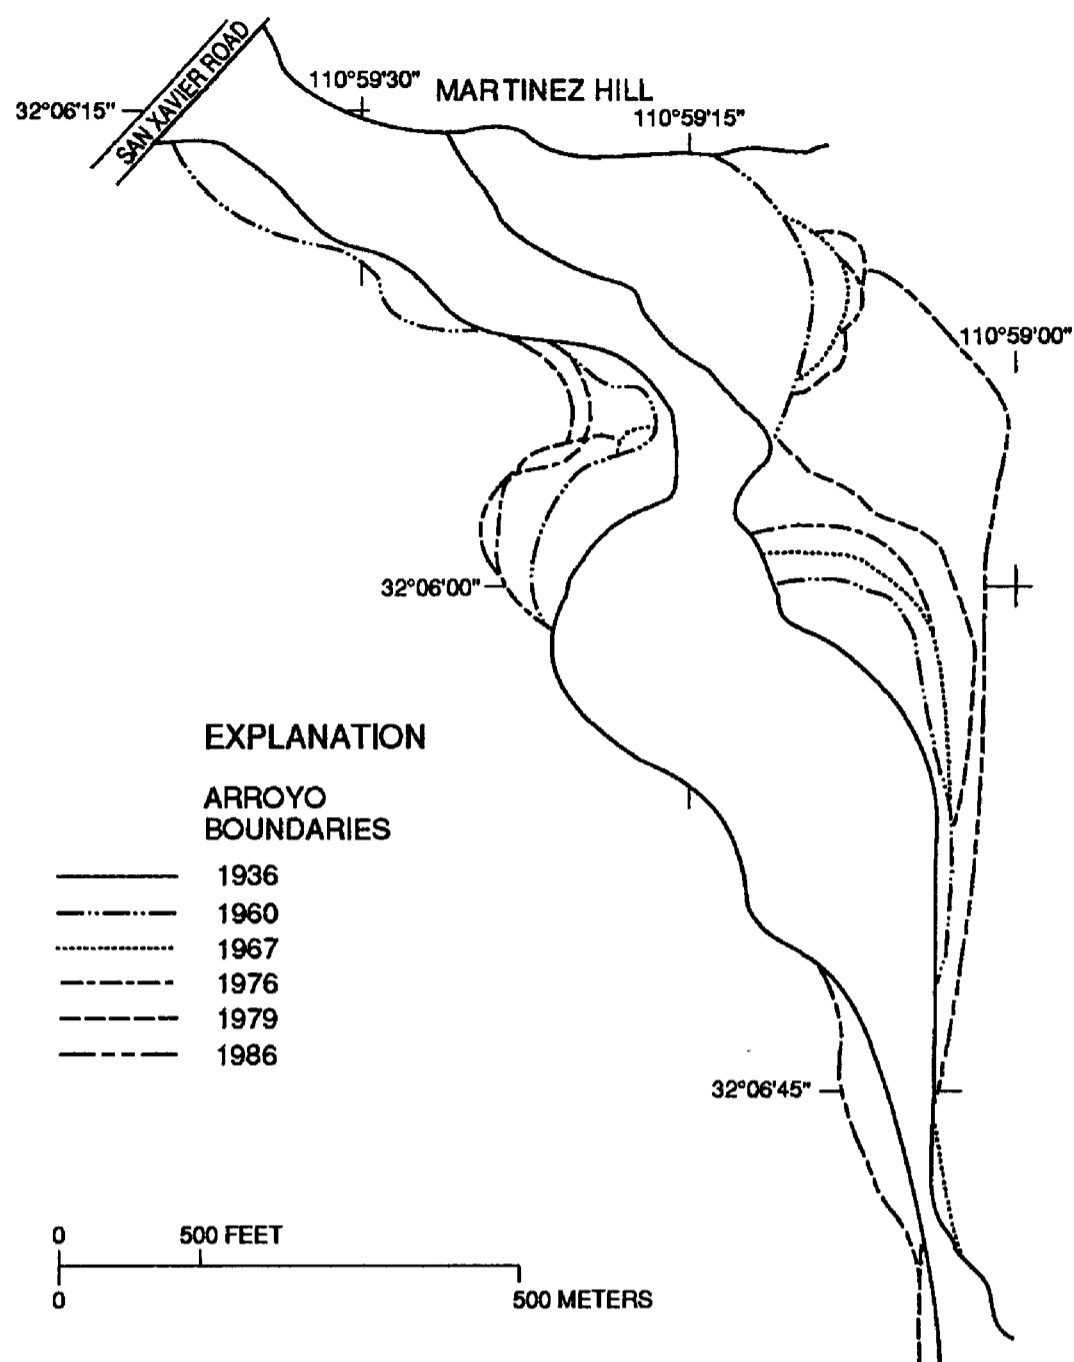
Figure 17. Arroyo widening caused by migration of entrenched meanders in the San Xavier reach at Martinez Hill, 1936–86. (Source: Data from National Archives, 1936; Cooper Aerial Survey, 1960, 1967, 1979, 1986; Kucera and Associates, 1976.)

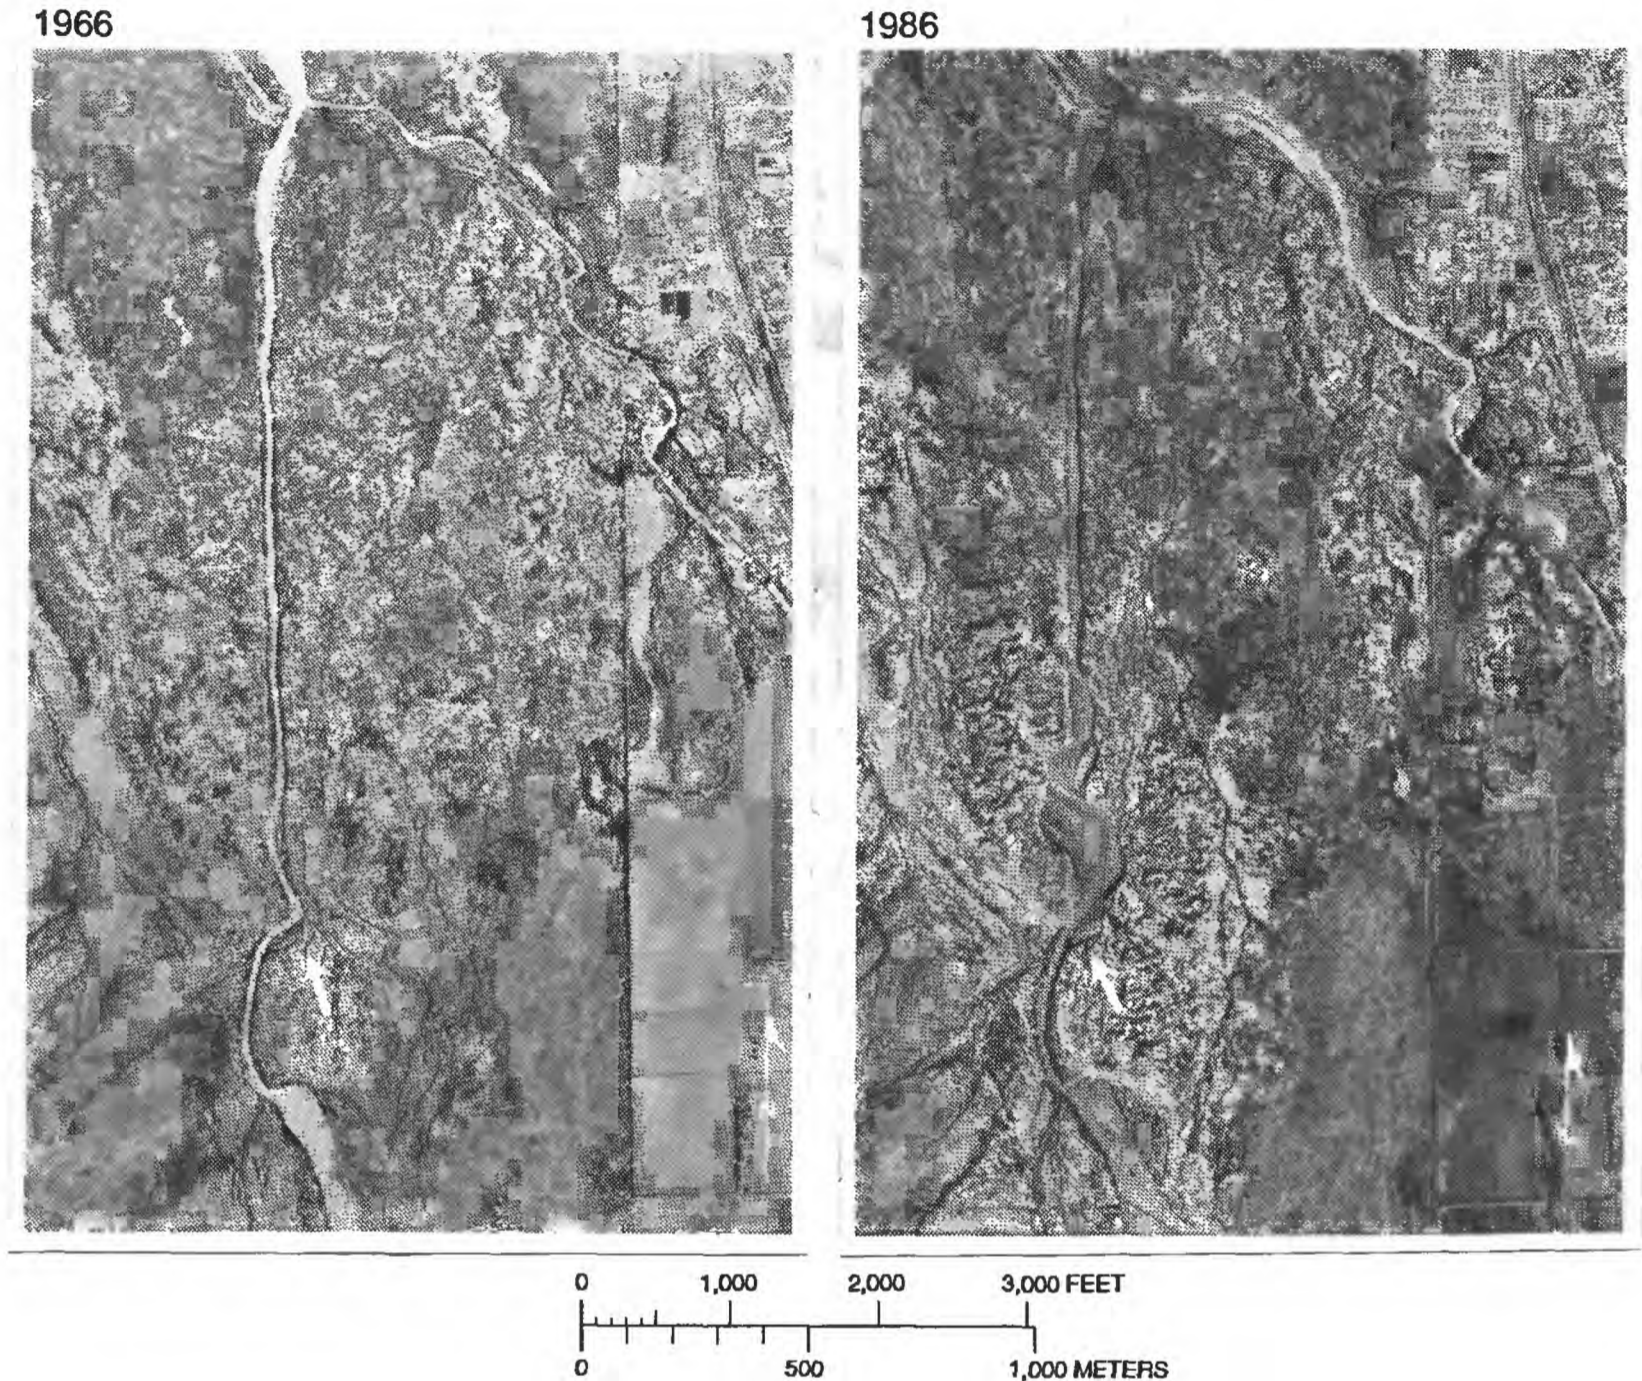
Figure 18. Changes on straight segment of the upper San Xavier reach, 1966–86. Arroyo width changed little except at the upstream end of the reach where an entrenched meander was migrating into the straight segment. Most of the change occurred during the flood of 1983. (Source: U.S. Geological Survey, EROS Data Center, 1966; Cooper Aerial Survey, 1986.)

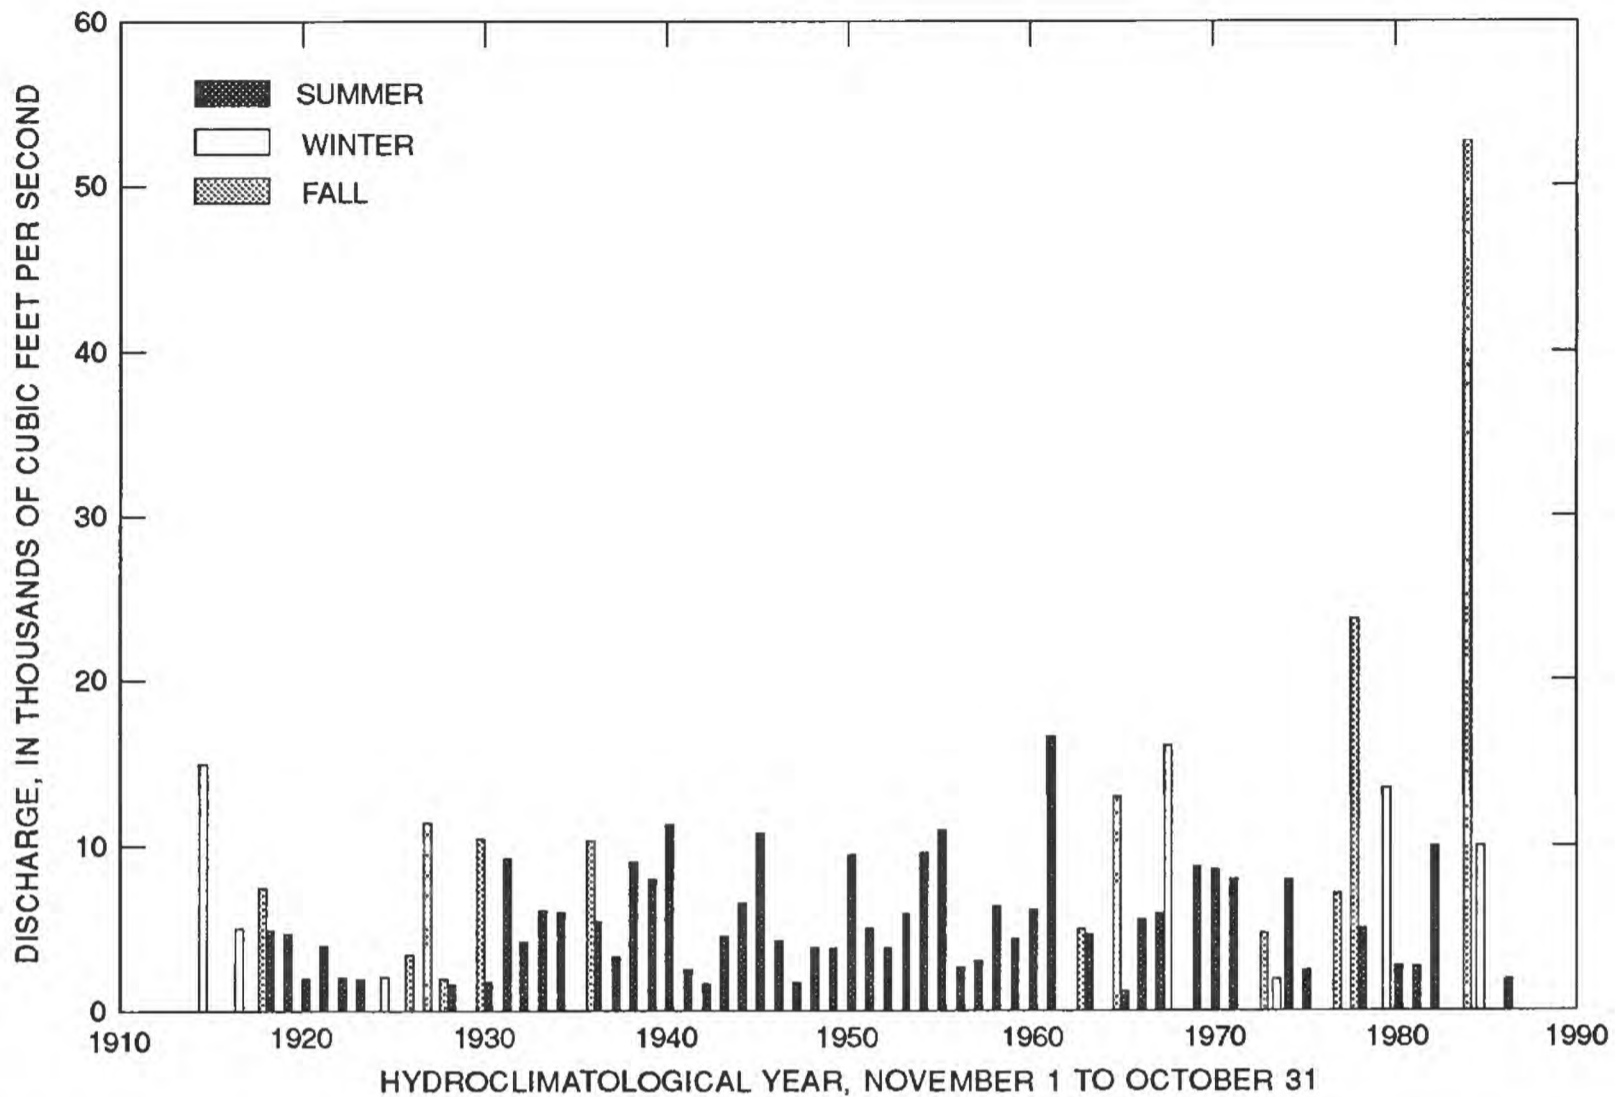
Figure 19. Annual flood series for the Santa Cruz River at Tucson. (Source: Data from Webb and Betancourt, 1992.)

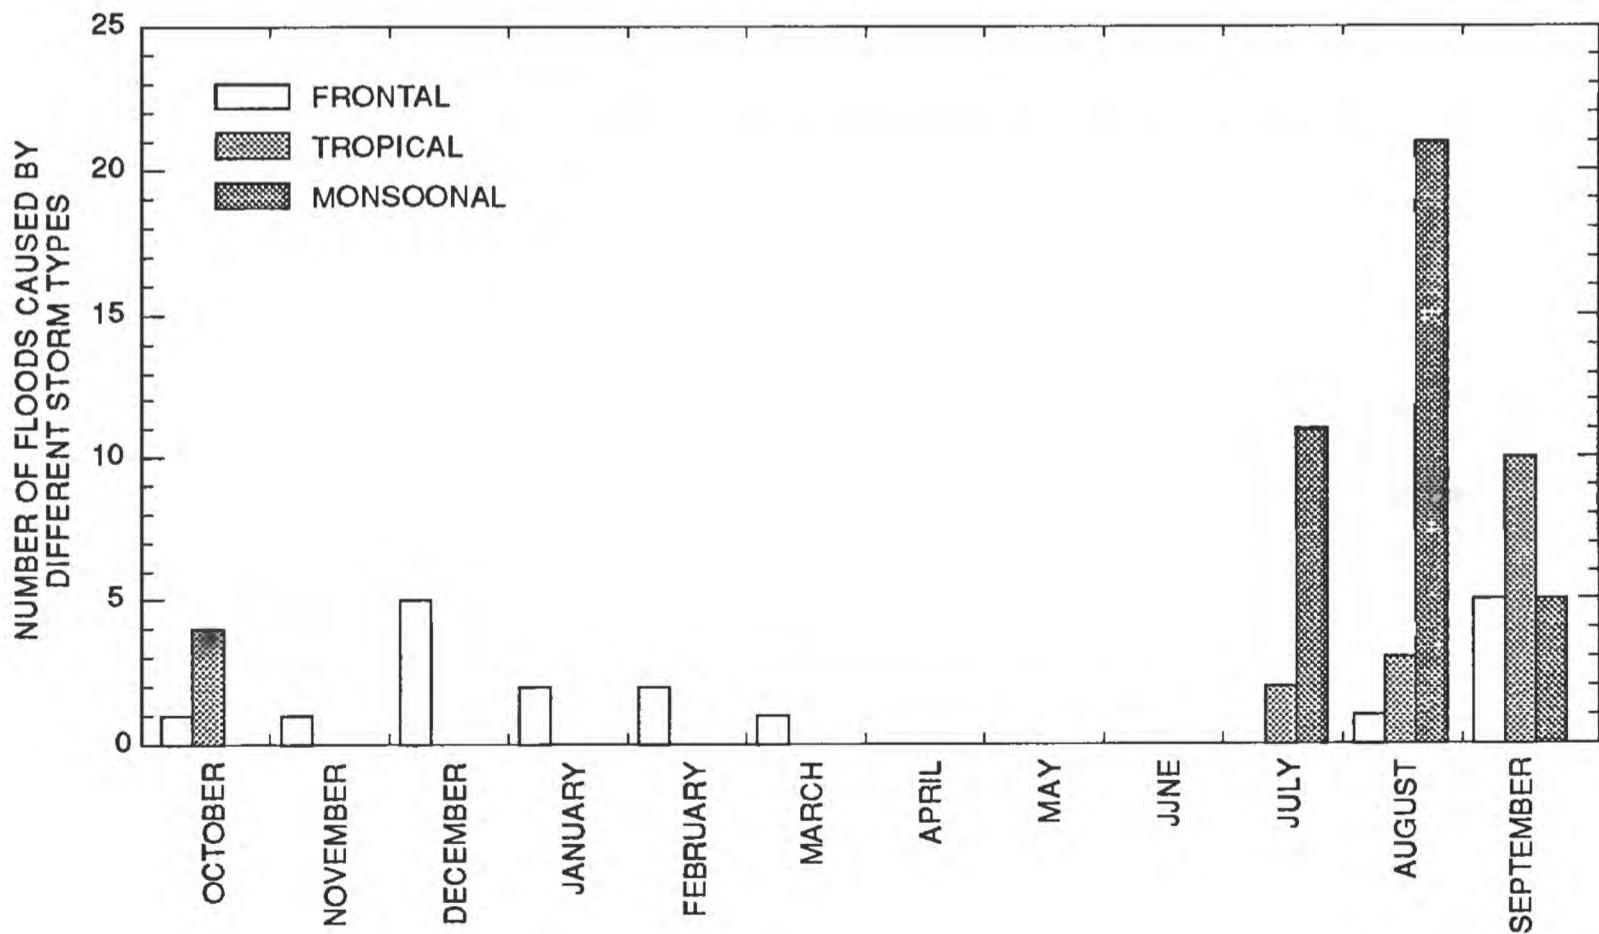
Figure 20. Seasonal occurrence of floods at Tucson caused by monsoonal thunderstorms, frontal systems, and dissipating tropical storms, 1914-84. (Source: Data from Webb and Betancourt, 1992.)
